# Inspecting Rail Tank Cars

*Union Tank Cars' new plant in Alexandria, La., makes use of the latest inspection technologies*

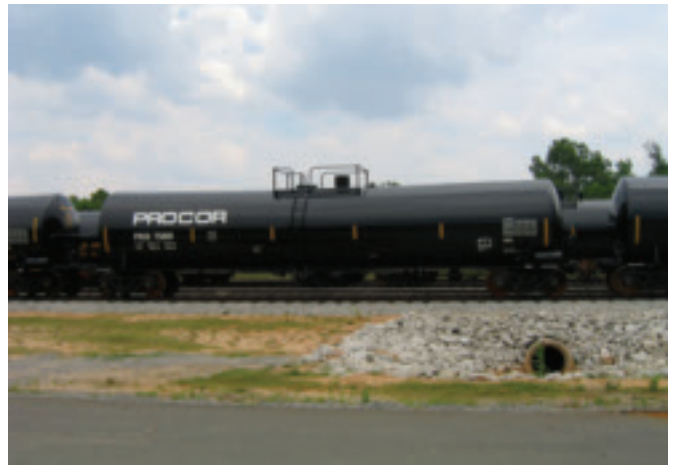
Fig. 1 — Completed tank cars awaiting delivery.

When you visit the new UTLX Manufacturing, Inc., plant in Alexandria, La., you'll see rows of gleaming ebony tank cars awaiting delivery (Fig. 1) and a massive manufacturing space filled with workers, equipment, and dozens of tanks in various stages of assembly. However, you won't see any vats of chemicals awaiting use or containers of spent chemicals. That's because this new plant only uses digital x-ray equipment, with its resultant benefits of real-time, easier-to-analyze results, fewer environmental issues, and space savings.

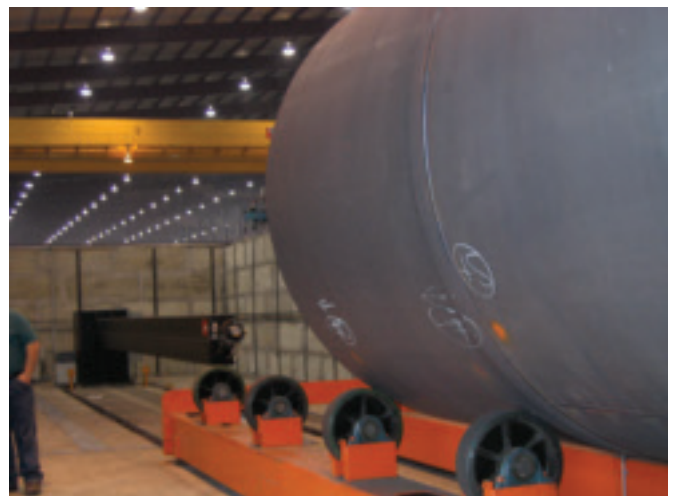
Fig. 2 — A tub being loaded onto the fluoroscope.

The tubs are transported into the two bays for the fluoroscope — Fig. 2. A real-time, 100% scan takes approximately 40

minutes; checking the junctures of the long horizontal joint, girth joint, and head joint takes approximately 8 minutes. Speed is the primary benefit of the fluoroscope, Edgel explained. If they used traditional, film-based radiography, it would take a three-person crew from 3 to 4 hours to shoot one tub.

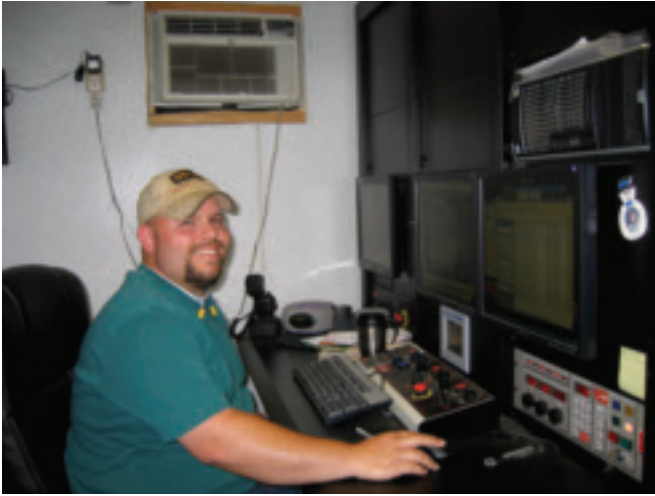
*Fig. 3 — Inspector Jason Couvillion operates the fluoroscope and interprets the x-ray images. Porosity, slag, and incomplete fusion are the more common discontinuities he'll locate with the equipment.*

Inspector Jason Couvillion had 12 years of experience before joining UTLX — Fig. 3. “With this machine, you are x-raying and interpreting the x-rays simultaneously,” he explained. “Porosity, slag, and incomplete fusion are the three most common defects we’ll find with the fluoroscope.”

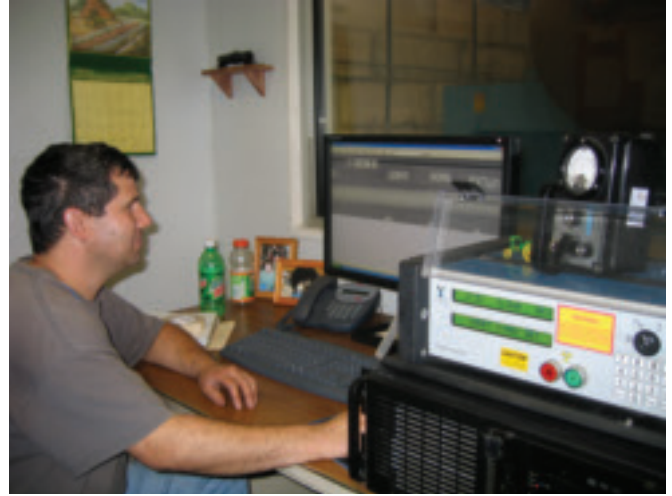
*Fig. 4 — Inspector Spencer Scallan examines a CMOS image. The CMOS equipment is used to inspect the closure weld that joins the two tubs together to form a tank.*

Somewhat later in the construction process, CMOS technology is used to inspect the closure weld that joins the two tubs together to create the tank — Fig. 4. Requirements for the closure weld are the same as for the welds inspected using the fluoroscope. The Alexandria plant is not the first UTLX plant to utilize this technology. “We developed this about two years ago in the Chicago plant,” Edgel explained. “It has proven to be durable in this type of environment.”

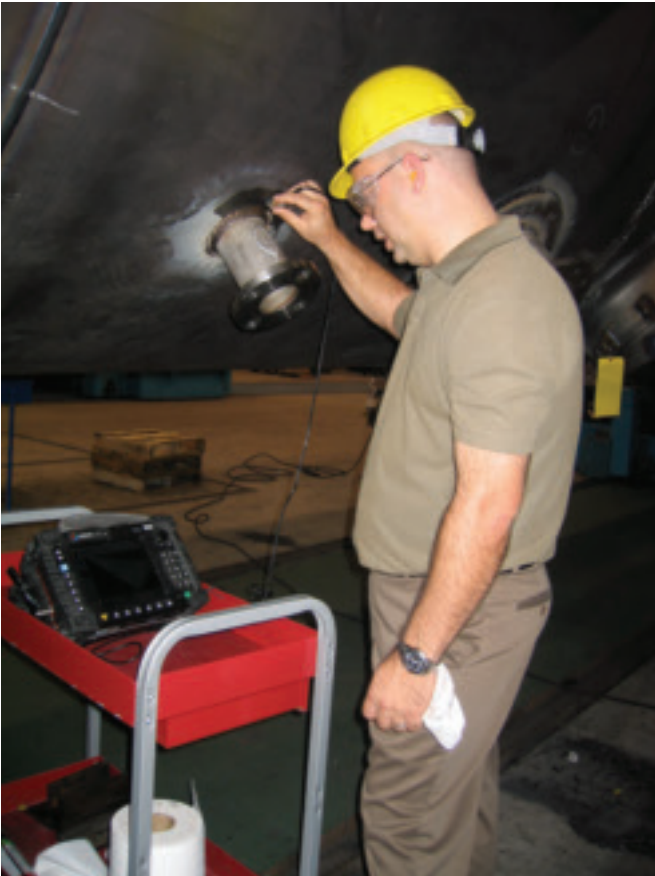
*Fig. 5 — Kenneth Leblanc, an ASNT Level II Certified UT inspector and Level III inspector in radiography, checks the quality of a nozzle weld.*

Once the tank bodies are completed, the company begins cutting the openings and then welding the manways, nozzles, and other items that are inserted into the tank. The company uses Omnican MX UT phased array equipment to examine all inserted nozzle welds (Fig. 5); this is a company standard, not a code requirement. This is not 100% inspection, but a sampling of one in every five welds. Again, they’re mostly looking for excessive slag, porosity, and incomplete fusion. “We don’t see cracks often, but we also look for them,” Edgel said. “This inspection is done behind every welder, not every car. We’re checking the quality of the welder.”

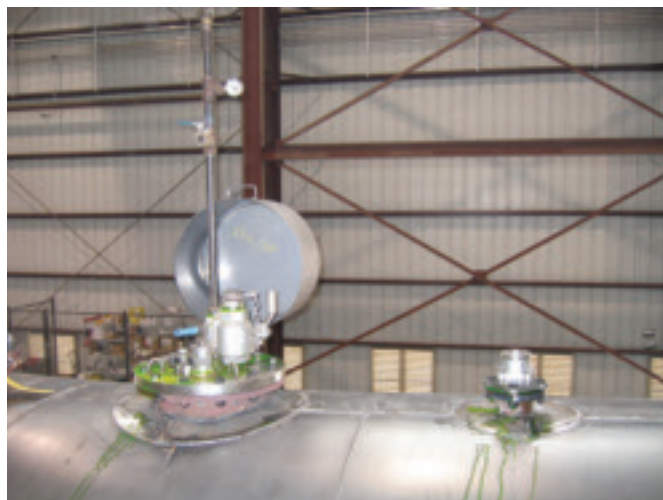
Fig. 6 — Once all the fittings have been attached, the inside of the car is checked for cleanliness, all openings are closed, and the car pressurized to determine there are no leaks at any of the fittings.

As the tank cars near completion, fittings such as manways, air vents, and safety valves are added. Inspection Manager Dan Glad explained inspectors check each fitting to make sure the correct parts such as valves have been added, determine the interior of the car is clean, close all the manways and valves, and then pressurize the car to 30 lb/in.<sup>2</sup>. Bubble tests are conducted to determine whether there are any leaks in the fittings — Fig. 6.
